INVESTIGATION OF HYDROTEST FAILURE OF THIOKOL CHEMICAL
CORPORATION 260-INCH-DIAMETER SL-1 MOTOR CASE

By John E. Srawley and Jack B. Esgar

Lewis Research Center
Cleveland, Ohio

in Collaboration with the
260-SL-1 Hydrotest Failure Investigating Committee

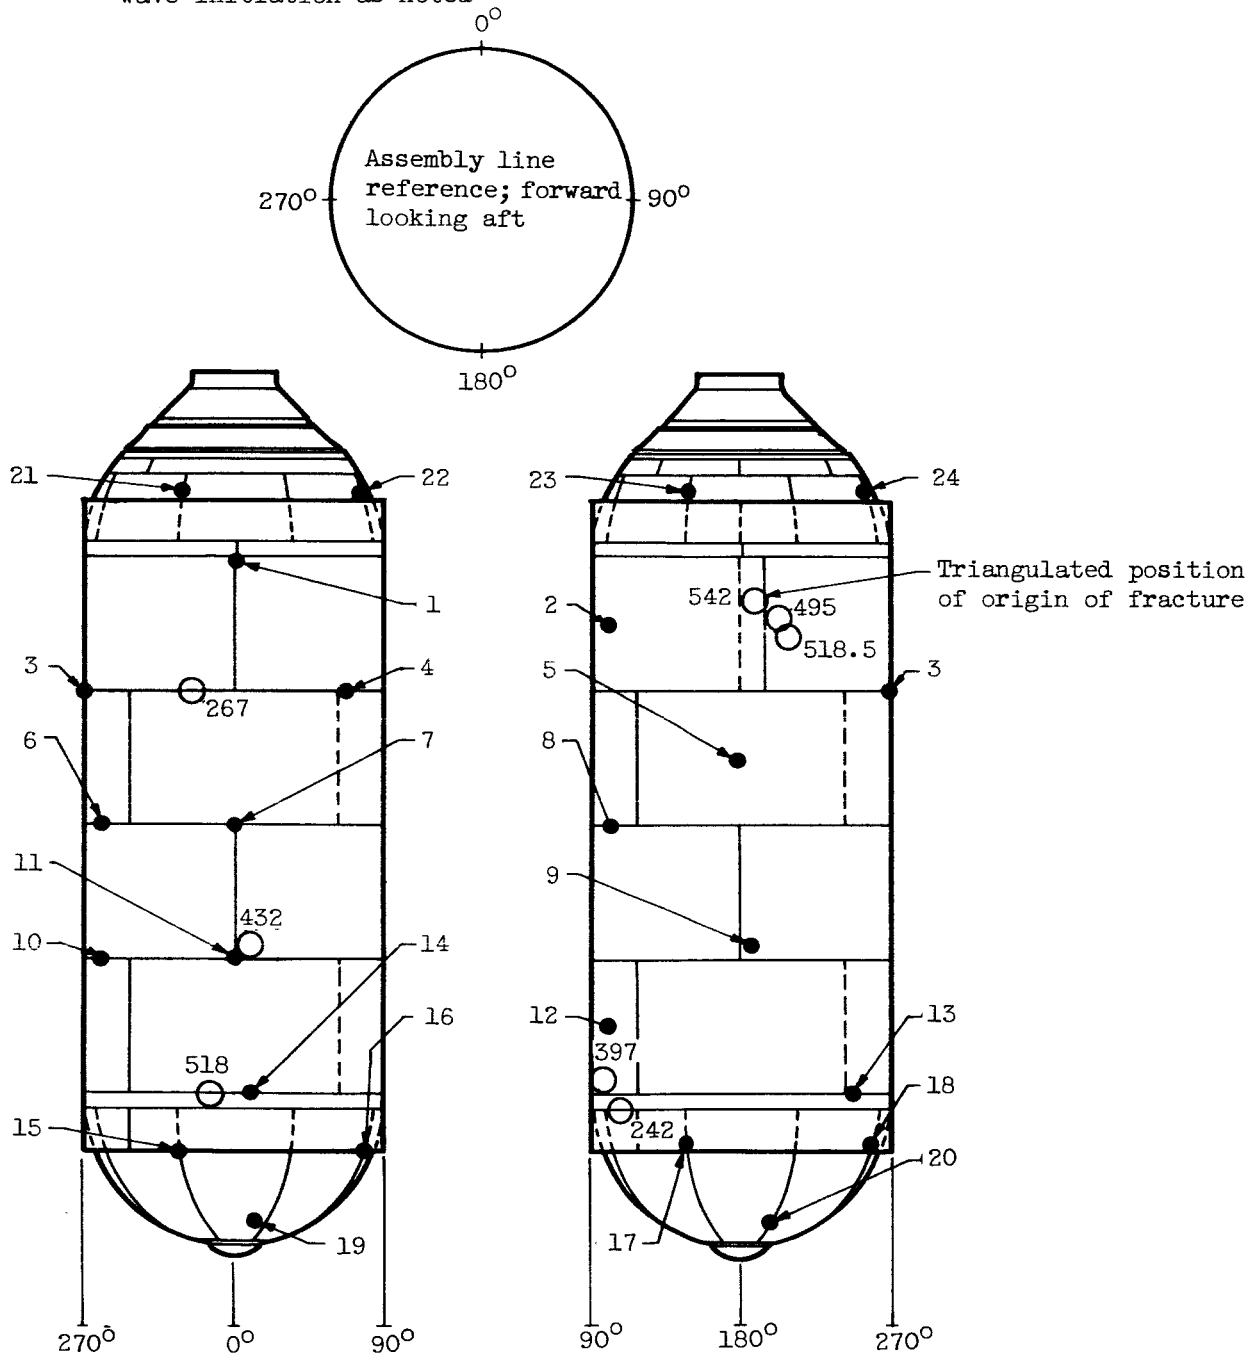
During hydrotest, the accelerometer system mounted on the motor case indicated eight stress waves, including the wave that occurred at failure. The predicted origins and the pressures at stress wave initiation are also shown in figure 3. The first stress wave occurred at a pressure of 242 psi. Previous experience in using a stress-wave detection system on hydrotest of motor cases has shown similar stress wave initiations in areas not related to final failure. Three of the stress wave origins were in the region of the lower skirt where the motor case was bolted to the hydrotest thrust stand. It is probable that some of these stress waves resulted from movement at the bolt holes.

Figure 3. - Locations of accelerometers and stress wave origins on 260-inch-diameter SL-1 motor case.

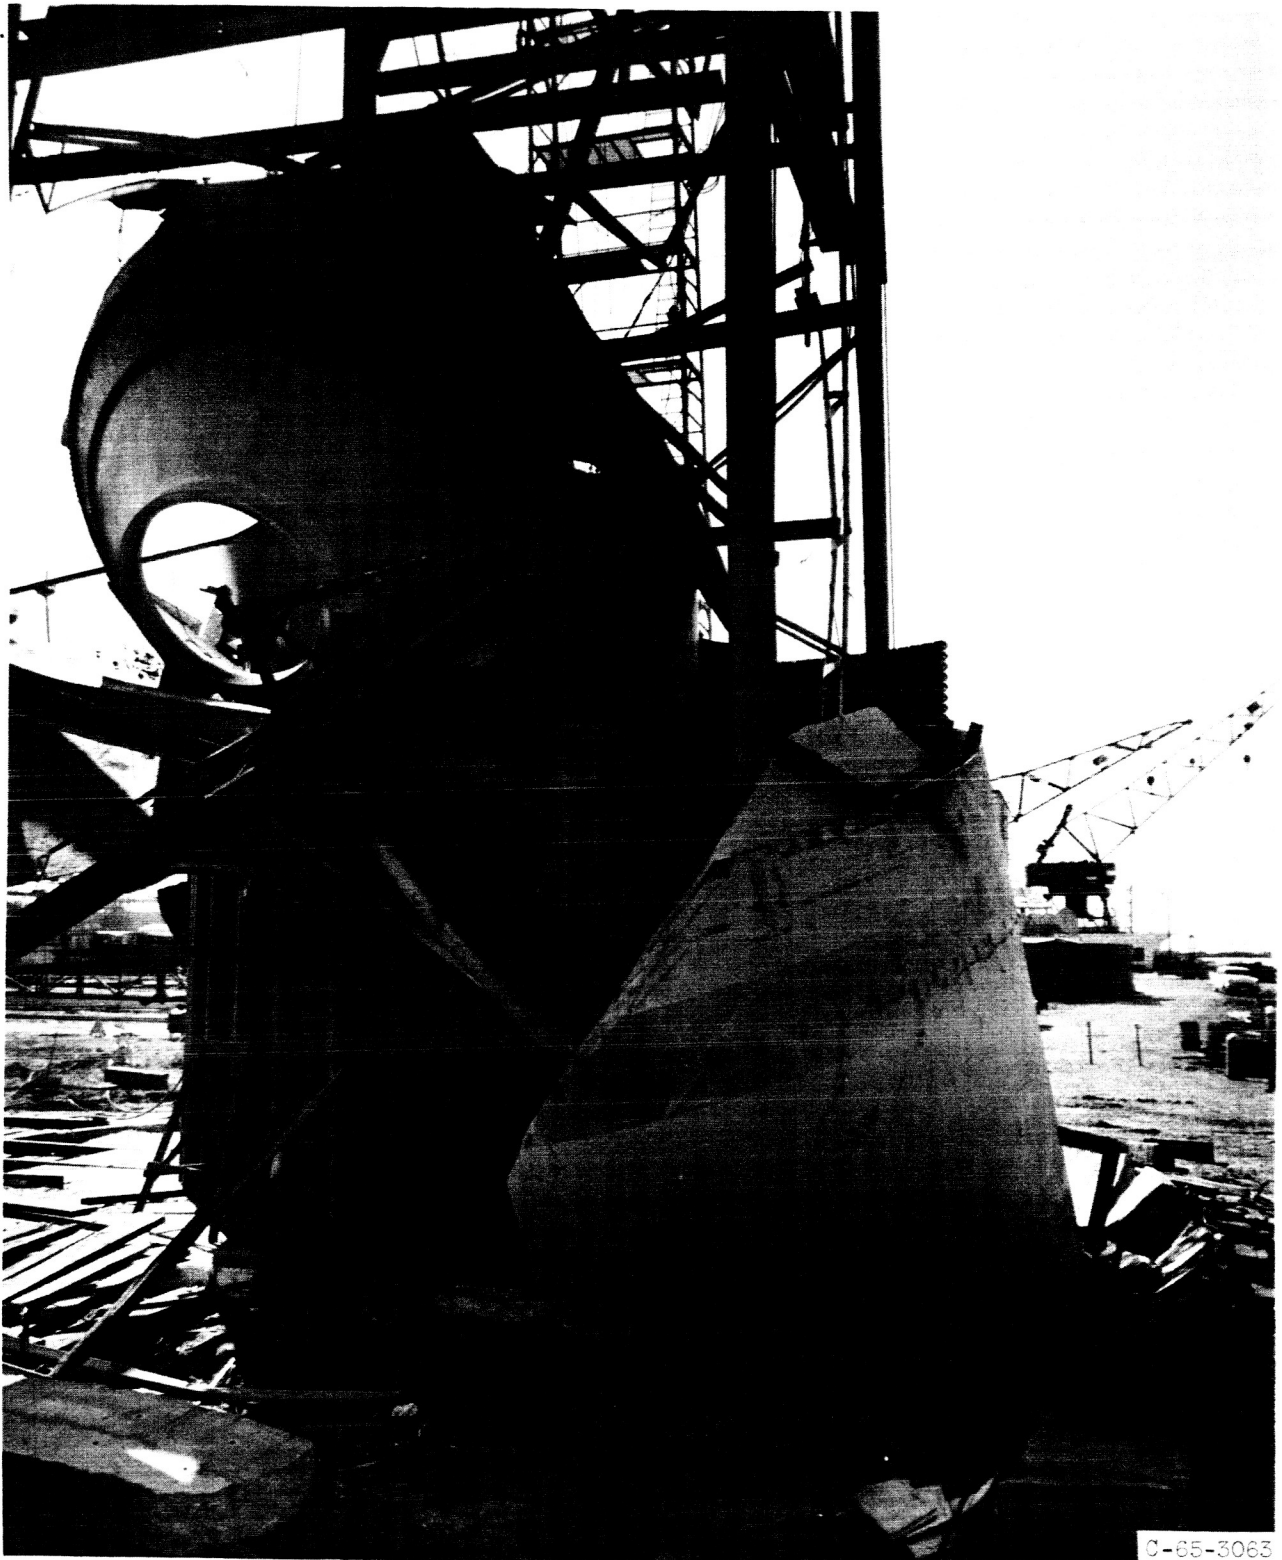
Figure 5. - Portion of failed motor case as it was being removed from hydrotest tower.

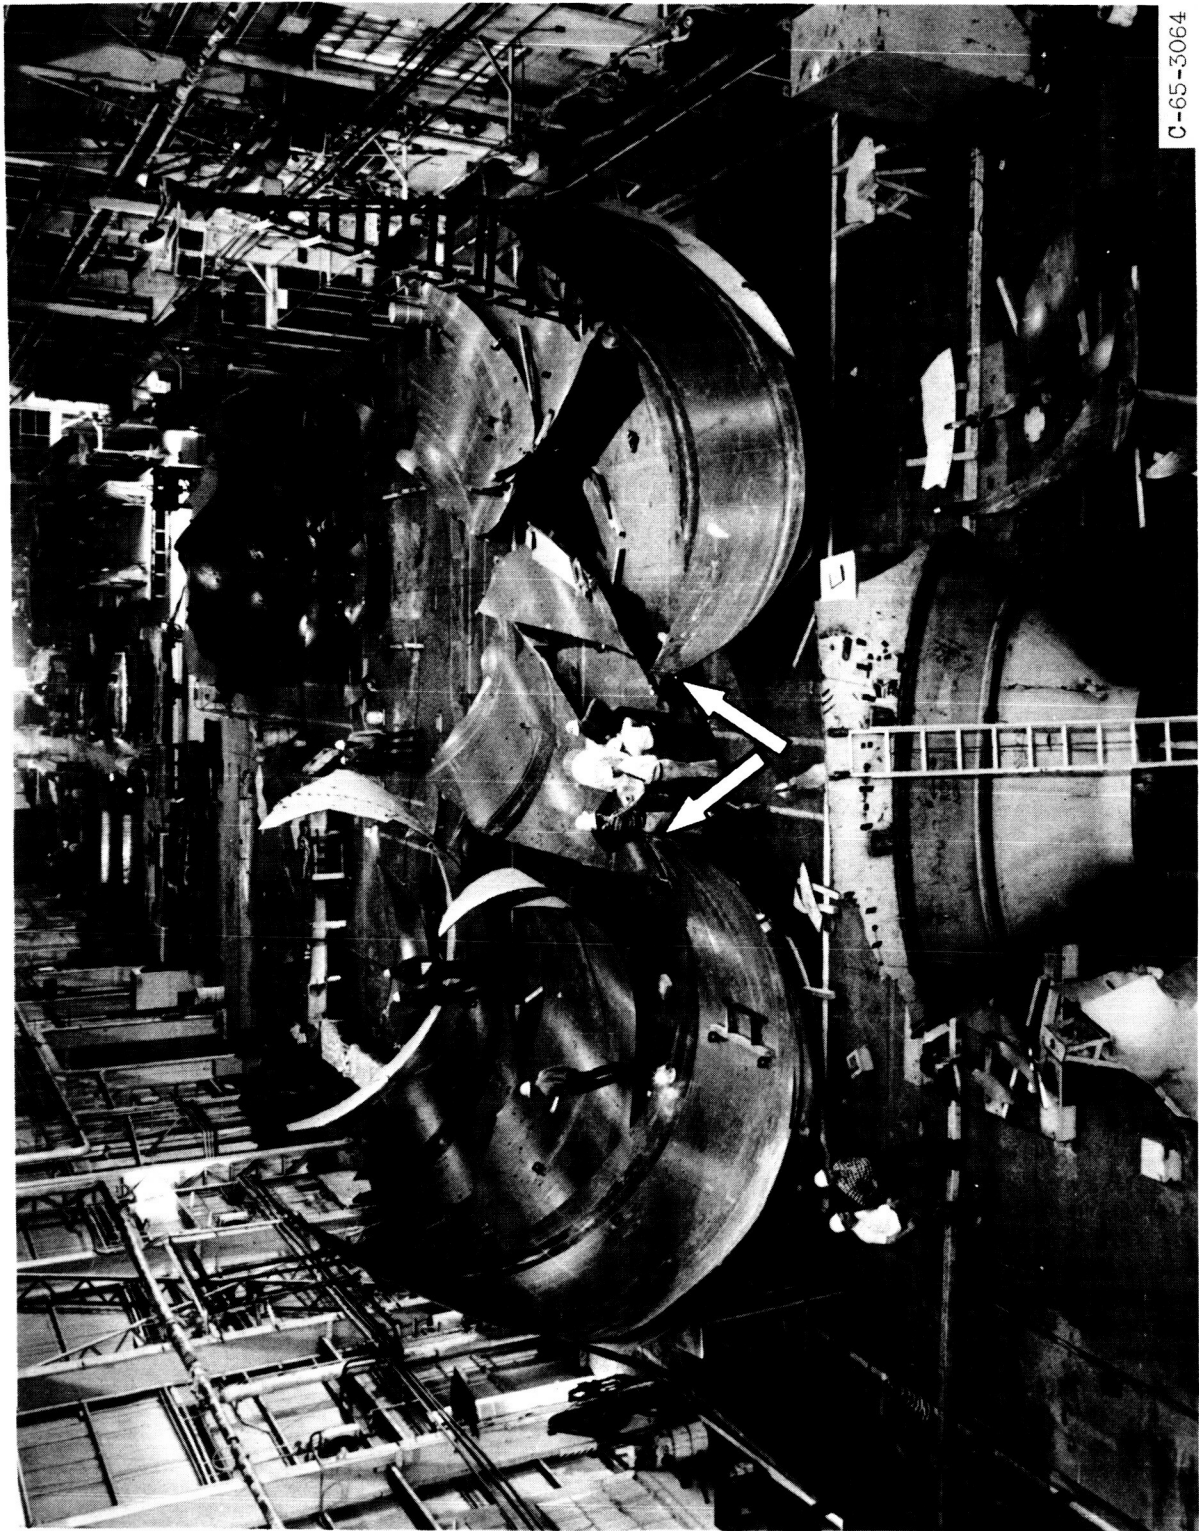
Figure 6. - Failed motor case with pieces laid out in approximately the proper relation to each other. View is looking forward with aft head in foreground. Origin of fracture indicated by arrows.

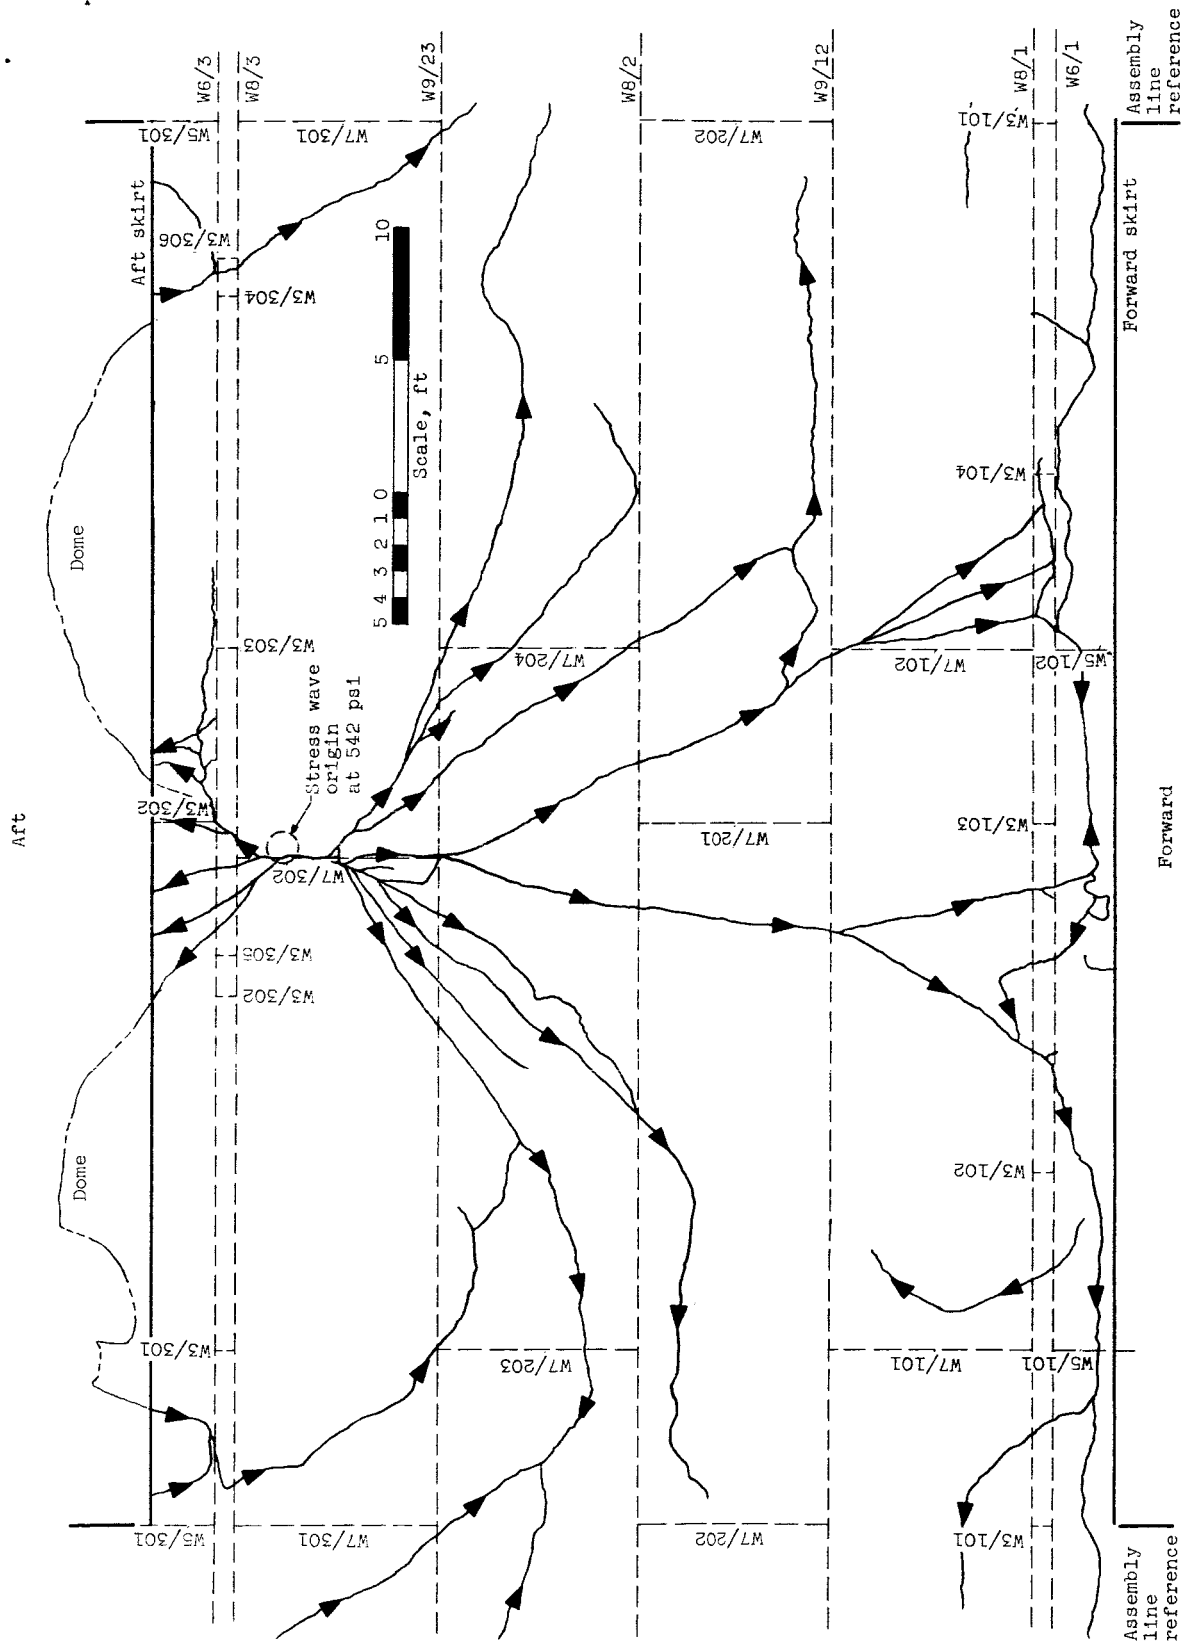
(a) Cylinder and skirts.

From the fracture map (fig. 7), it is clear that the fracture pattern developed from an origin close to the W7/302 longitudinal weld and somewhat forward of the W8/3 aft Y-ring weld. Although they are not shown here, the fracture paths in the skirts and the domes were completely mapped, and it was established that they had developed from cracks running out of the cylindrical section. There were no independent origins in these parts of the motor case, although there were one or two fracture branches that had run from the cylinder into one of the heads and then continued on back into the cylinder.

Figure 7. - Map of fracture paths as viewed when looking at inside surface developed onto plane obtained by unrolling cylinder. Arrowheads indicate directions of fracture propagation.

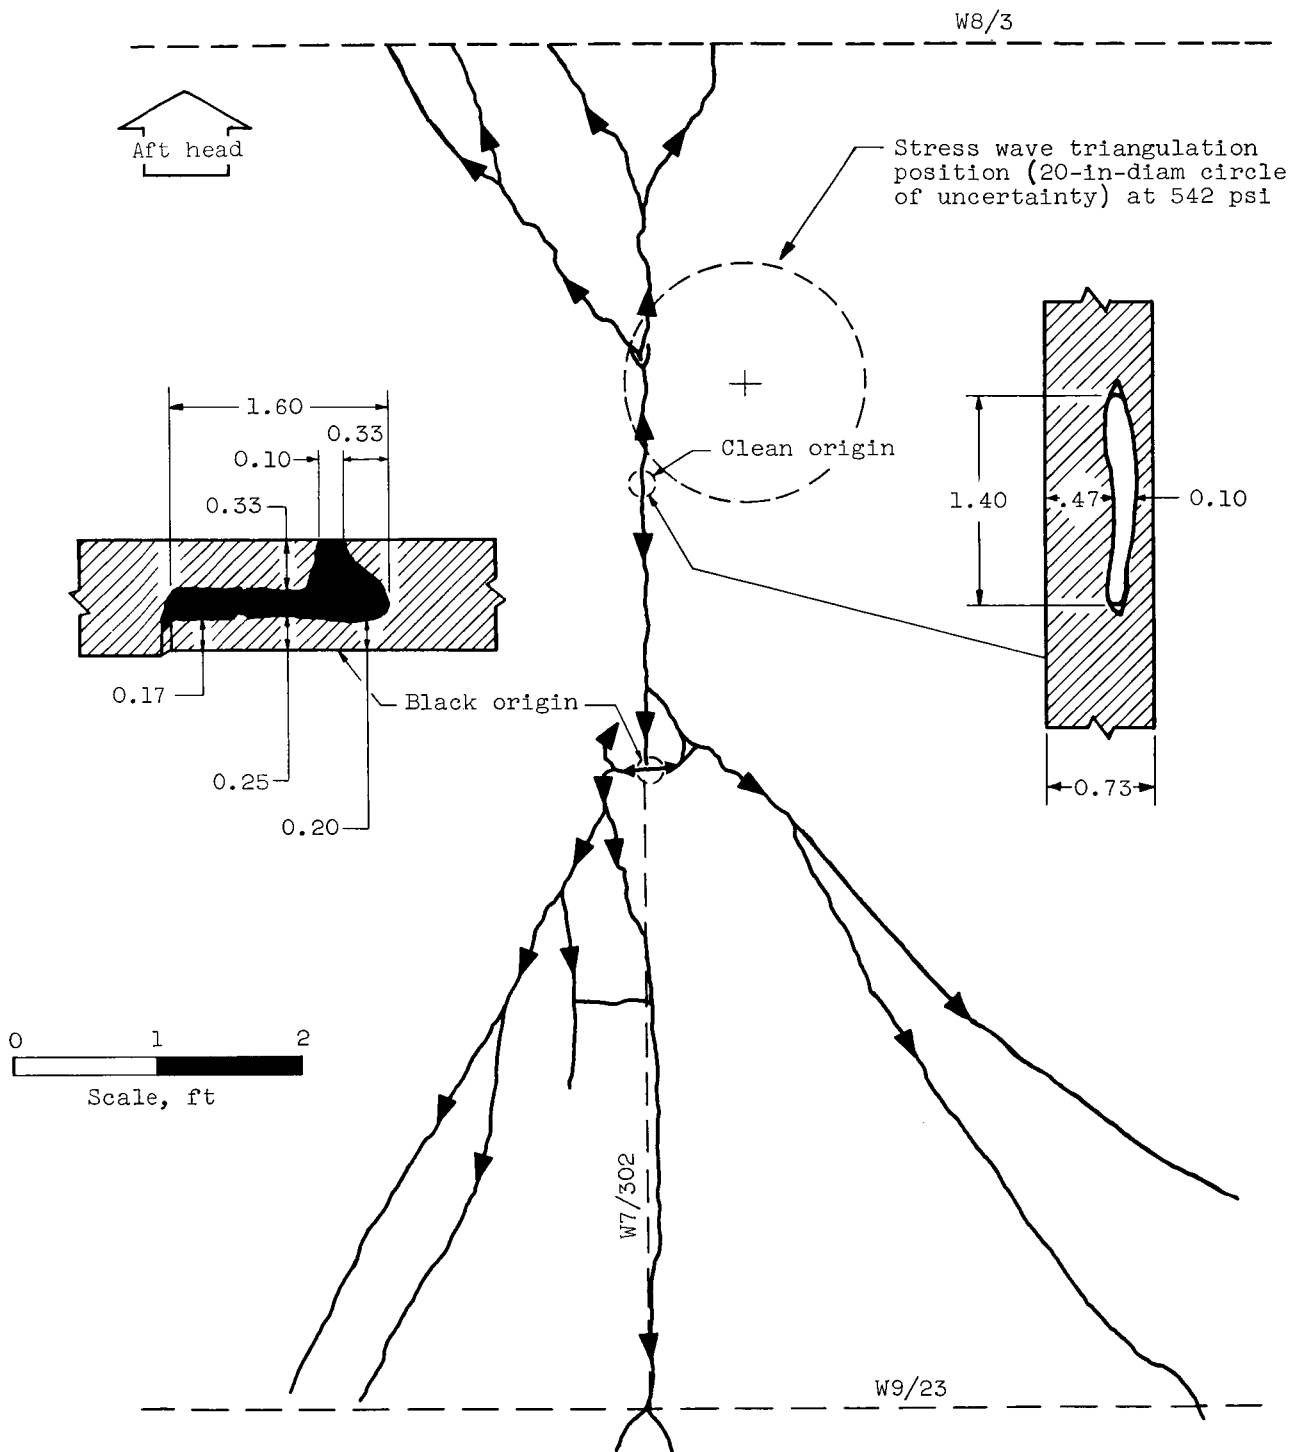
In fact, the local fracture pattern in figure 7(b) can only be explained satisfactorily if it is assumed that fracture started first at the clean origin with the initial, longitudinal crack running both aft toward the head and forward toward the position of the black origin. The intensity of the stress field around the black origin would have increased with the approach of the crack, so that secondary crack propagation would have been triggered at the black origin before the primary crack reached it. The subsequent intersection of the developing transverse crack by the primary crack would then have disturbed the stress field in a way that would account for the early branching of both ends of the transverse crack. Since the velocity of propagation of brittle fracture in steel can approach 5000 feet per second, it is likely that the interval between primary and secondary crack initiation would be of the order of a millisecond.

(b) Detail in immediate vicinity of primary and secondary origins. Inset sketches show shapes and dimensions of the two origins.

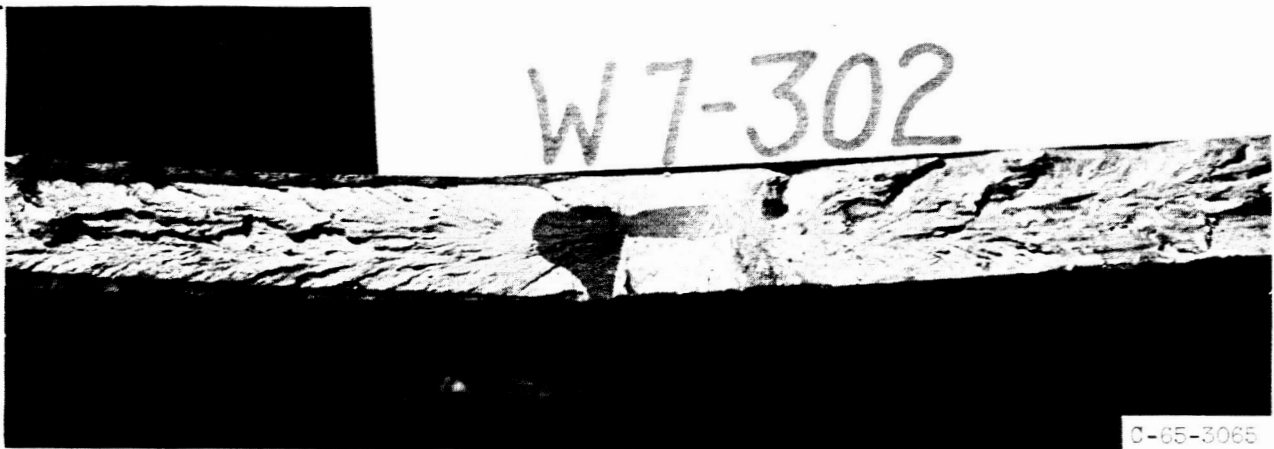
Figure 8. - Typical chevron markings on fracture surface showing directions of fracture propagation away from black origin.

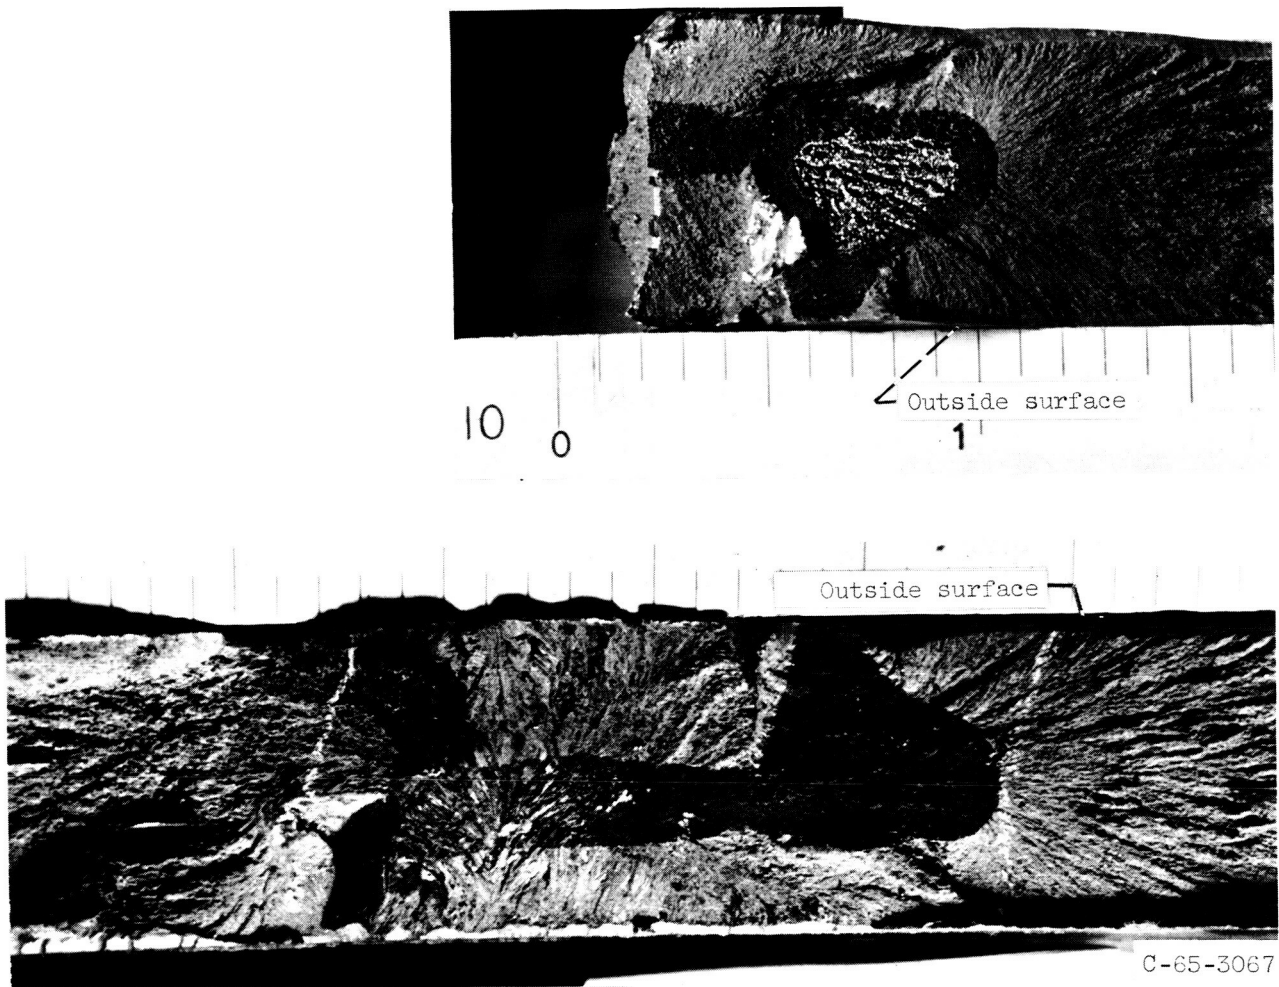
The black deposit on the transverse origin was examined by glancing-angle X-ray diffraction, electron diffraction, and electron-probe microanalysis. The diffraction patterns corresponded to a mixture of ferrous oxide (Fe_2O_3) and ferric oxide (Fe_3O_4). The analysis showed that the metallic constituent was predominantly iron with small amounts of nickel, molybdenum, cobalt, and titanium. This oxide must have formed at a high temperature. Comparison of the color with oxidized crack surfaces obtained by heating in air at high temperatures suggests a formation temperature at least as high as 800° F. It would appear that at least some of the oxidation must have occurred during the aging cycle at 835° F.

Figure 10. - Mating surfaces of black origin on W7/302 weld. (Part of black material has been removed from one surface for analysis.)

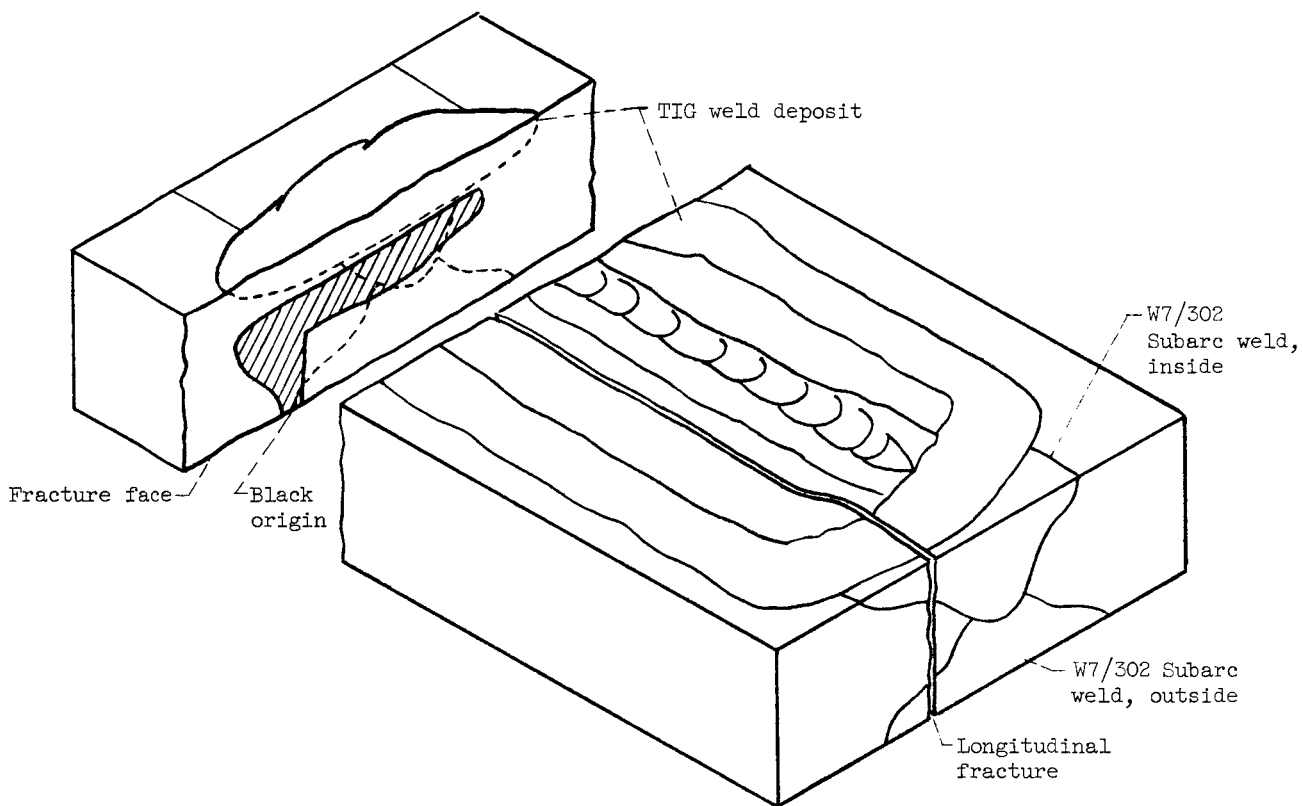
Figure 12. - Isometric drawing showing relation of black origin to weld deposits.

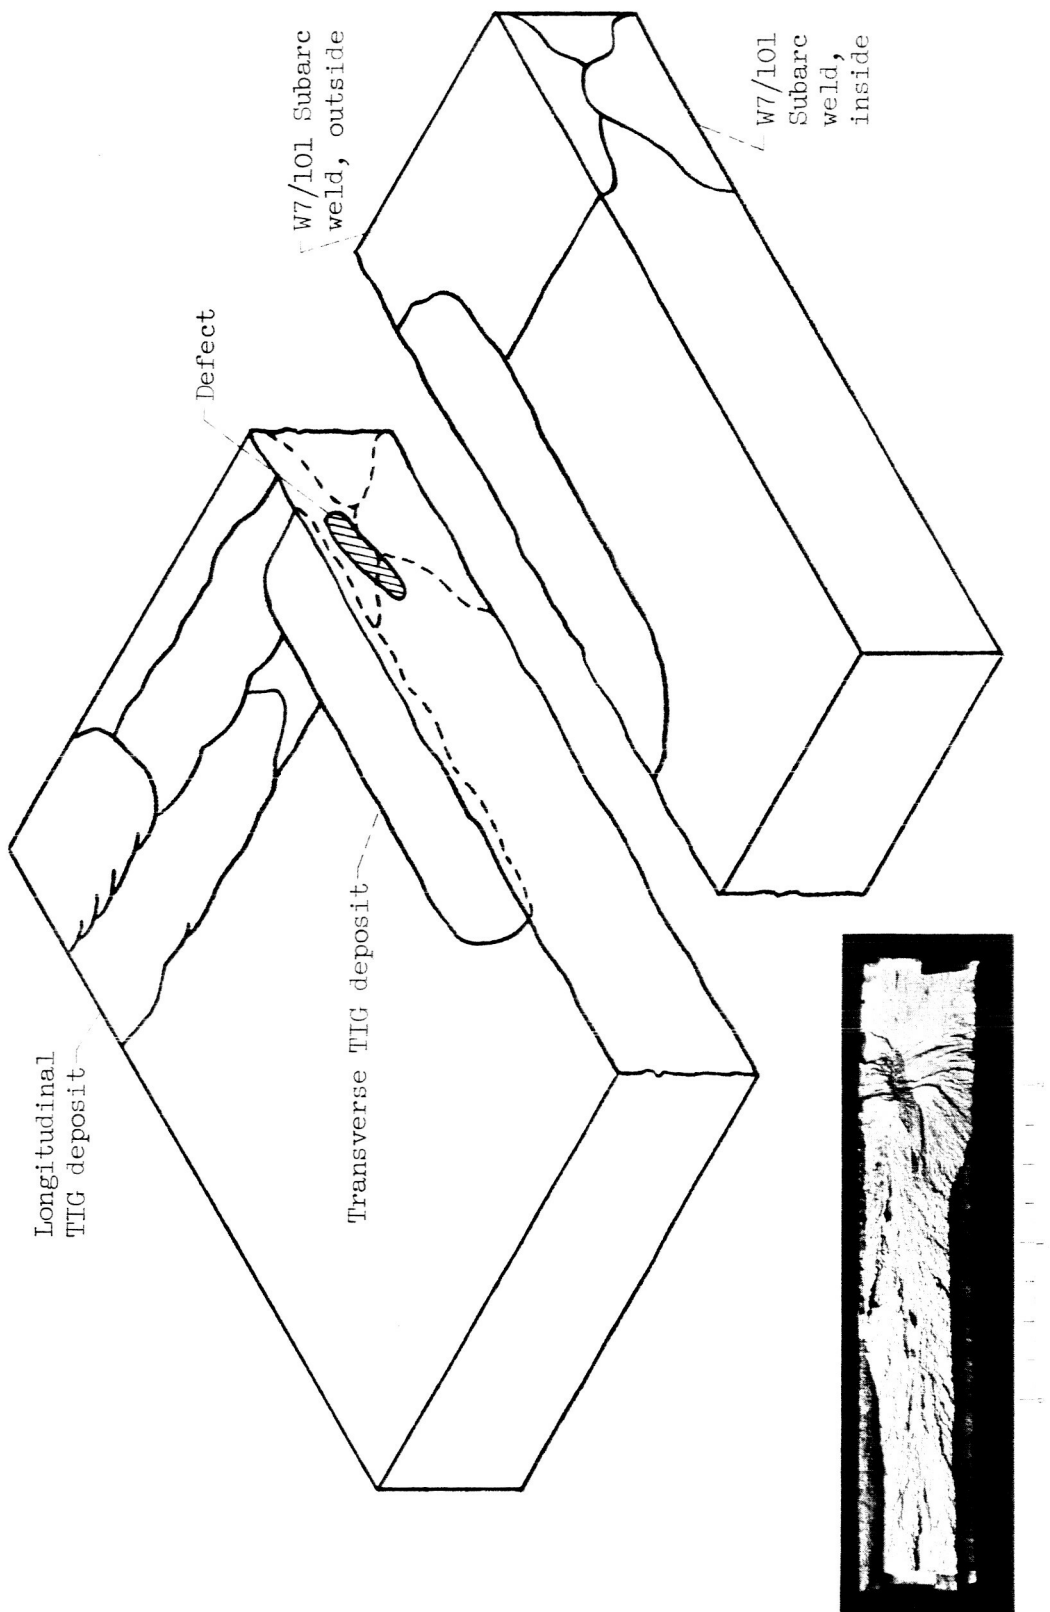
Figure 13. - Isometric drawing and photograph of fracture surface of longitudinal tension specimen from W7/101 weld region showing defect related to weld deposits.

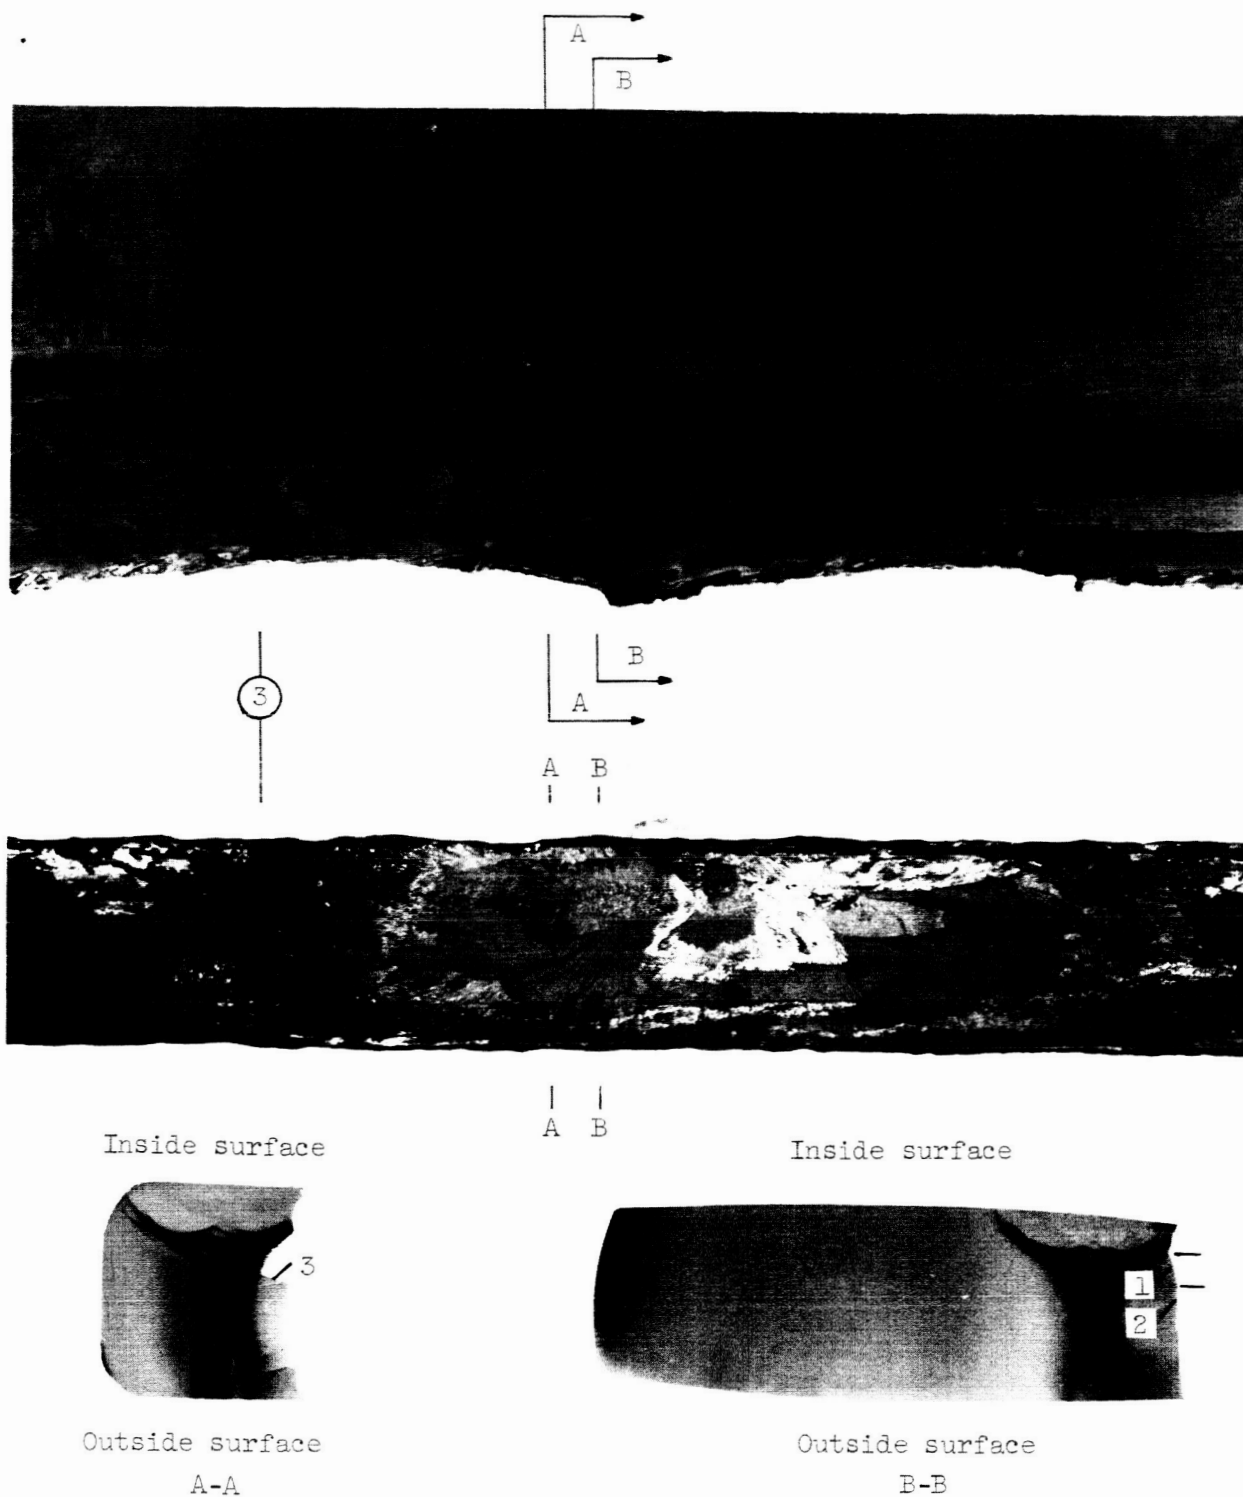
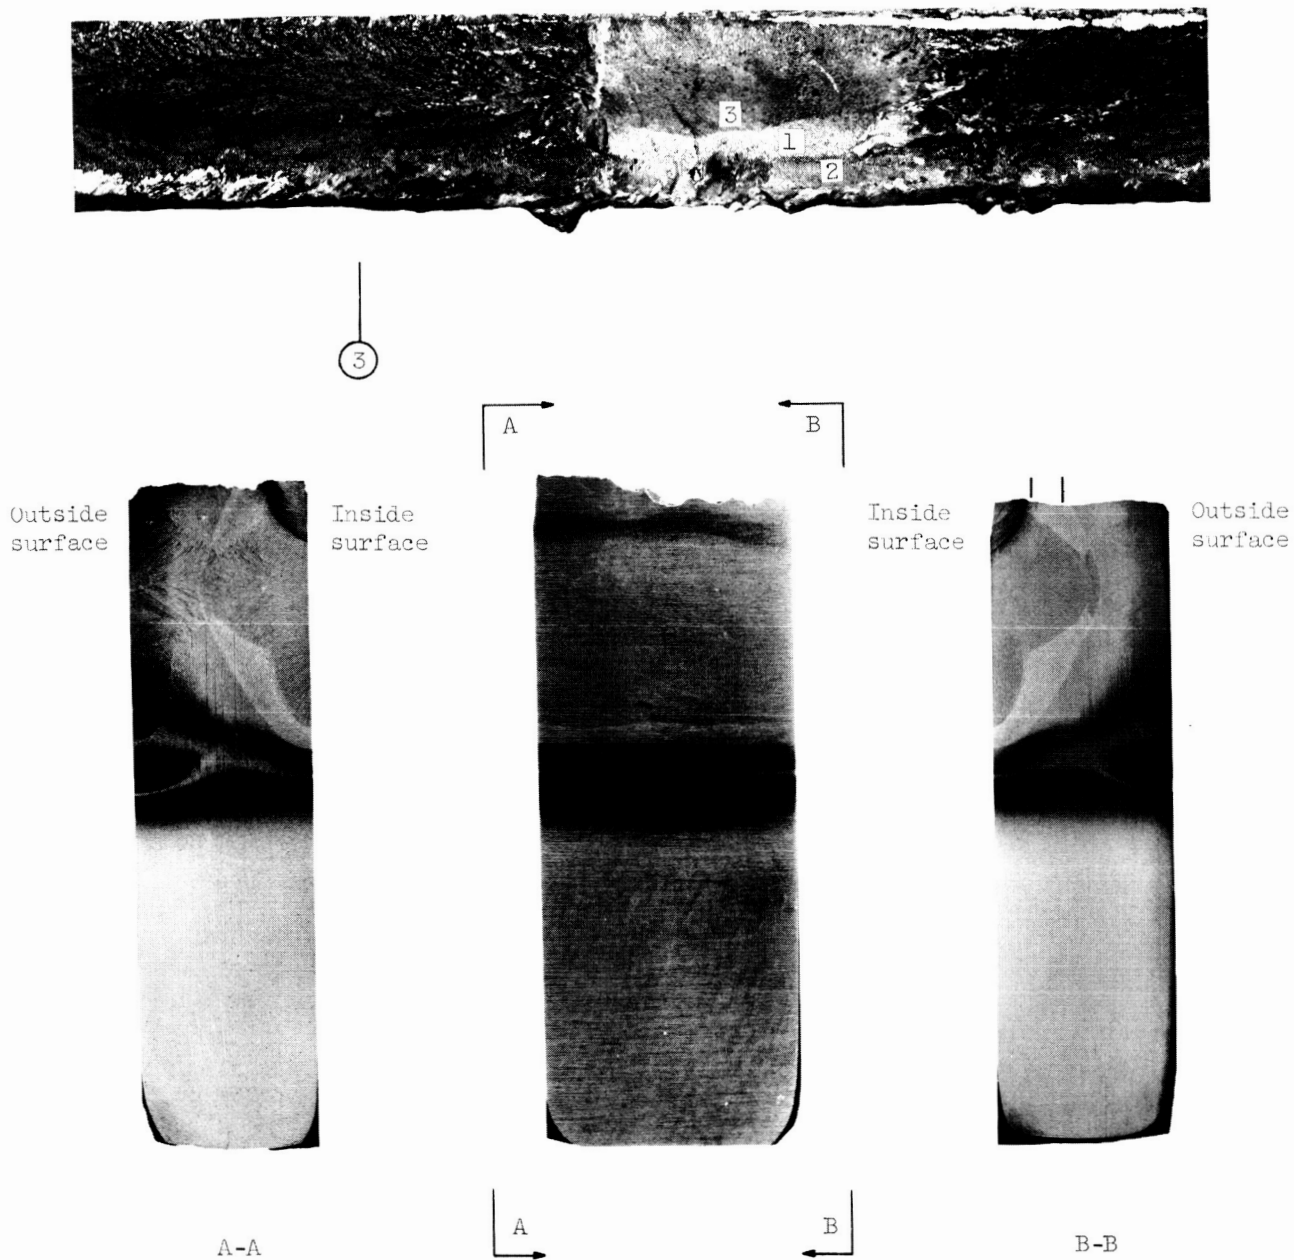
Figure 20. - Photomacrographs of clean defect region. $\times 1.5$.

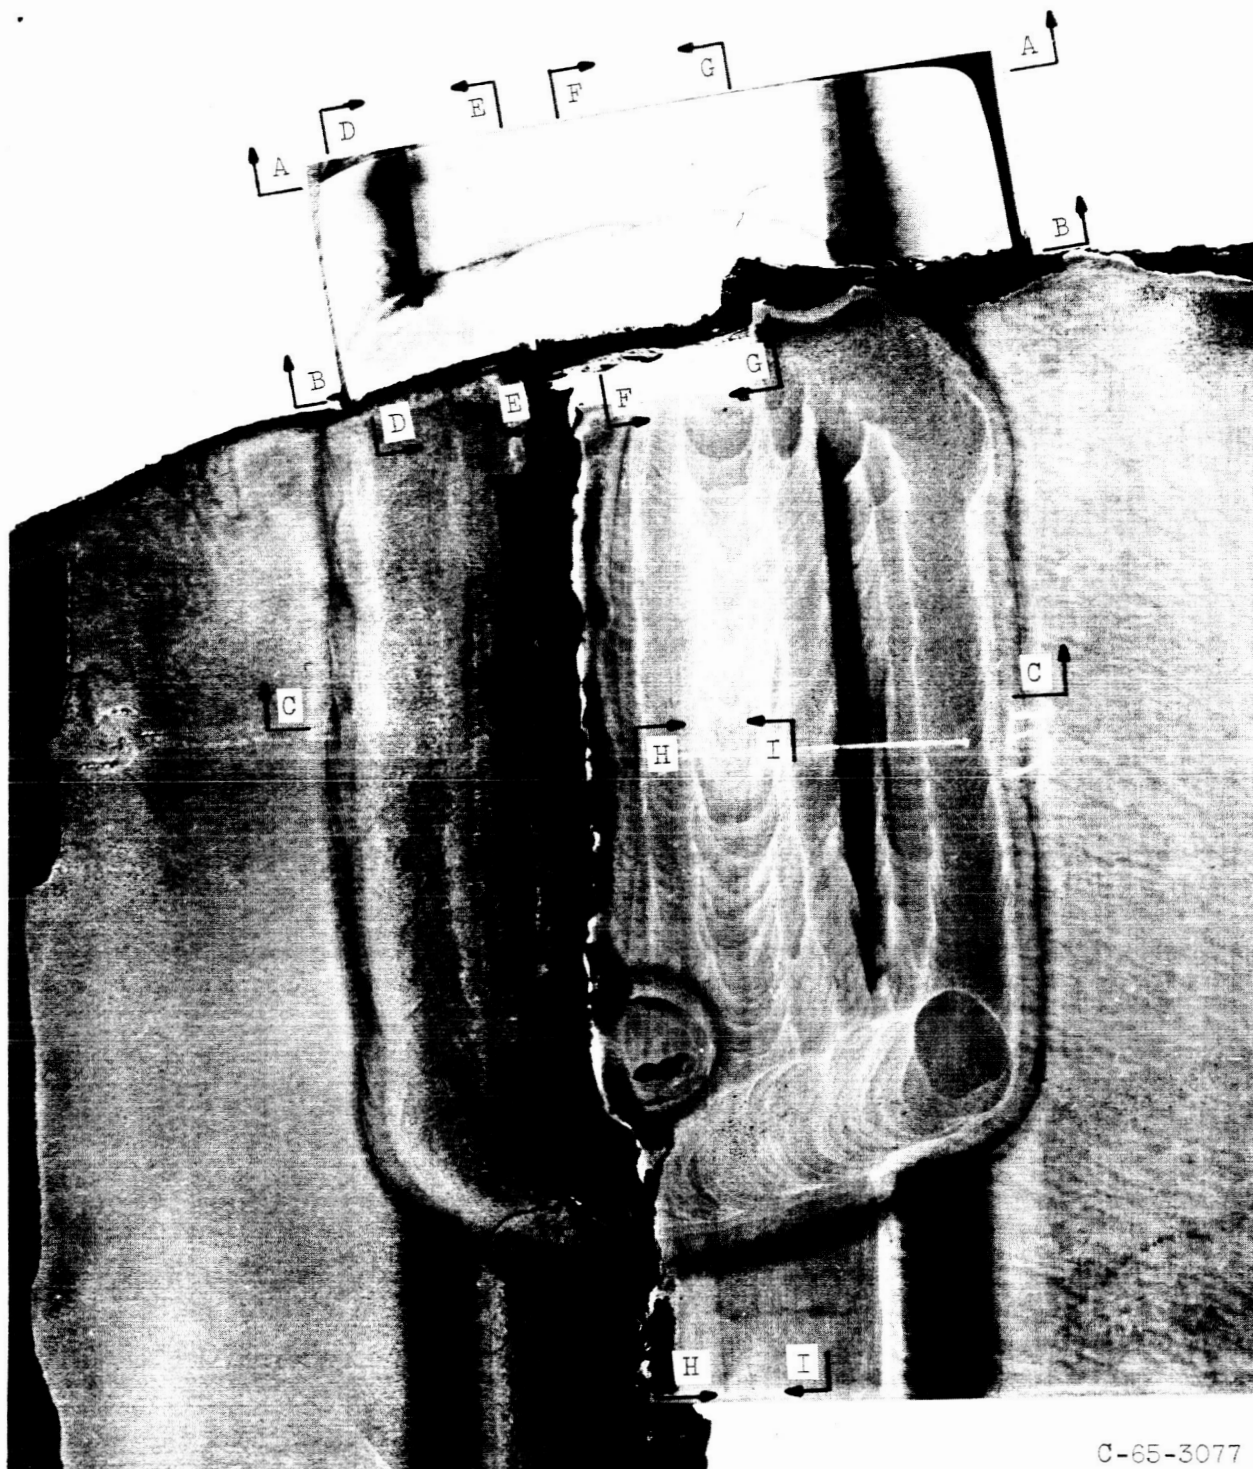
Figure 25. - Composite view of black defect region. Fragments 5, 6, and 8.
 x1.5.

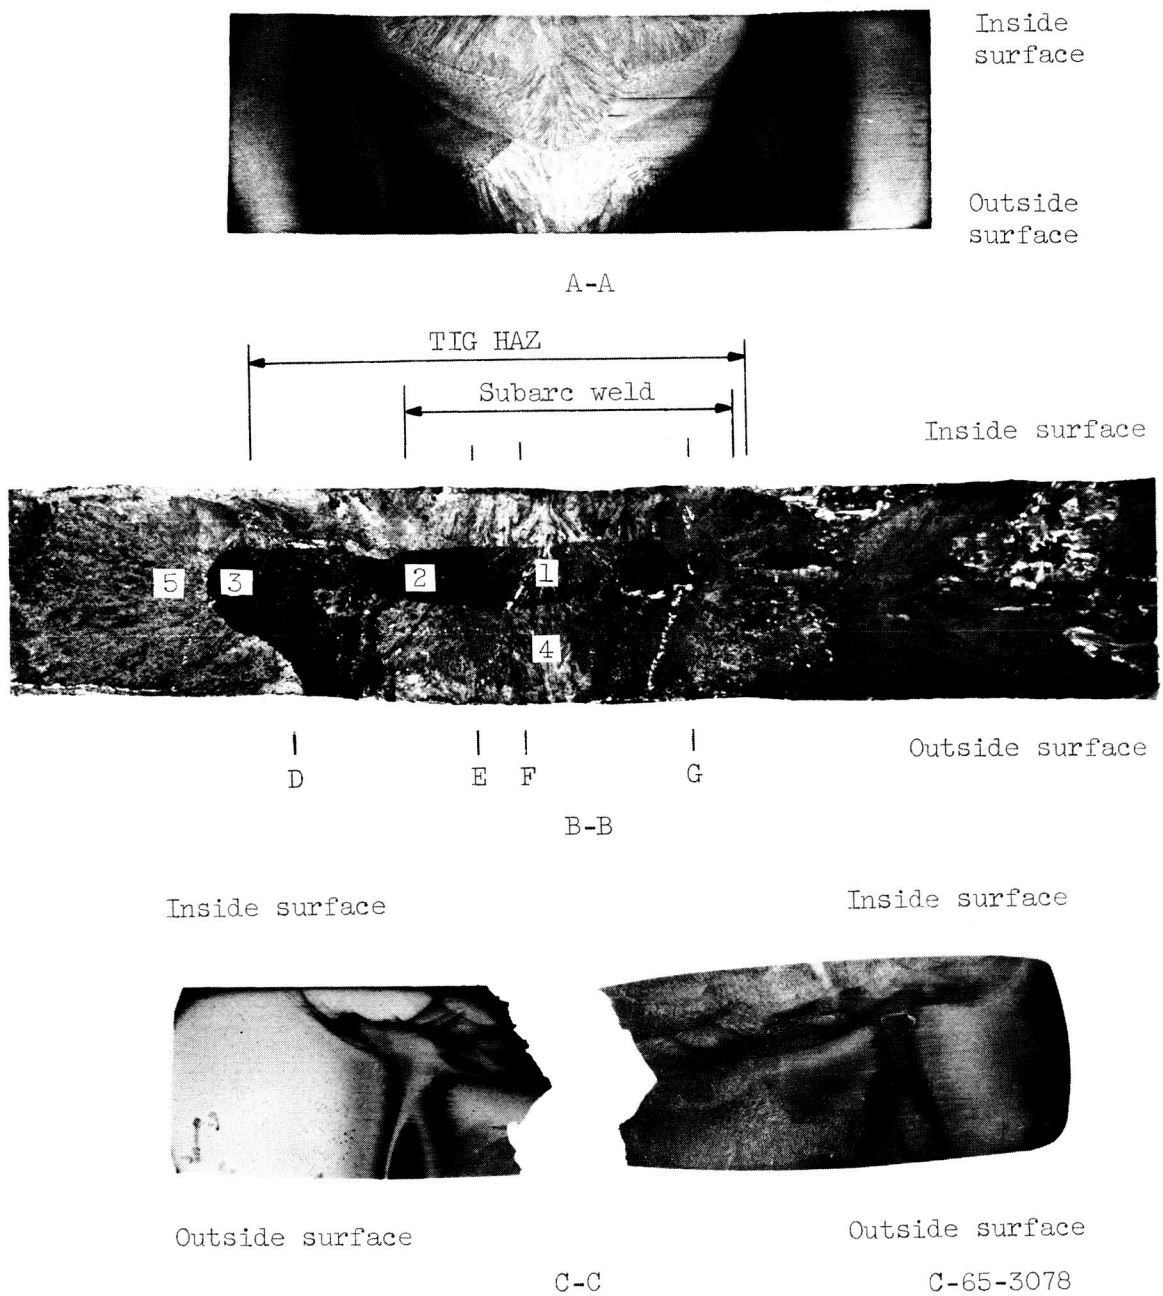
Figure 26. - Photomacrographs of black defect region (see fig. 25). $\times 1.5$.
